Grandstream Networks, Inc.

WP820

Battery Optimization Guide

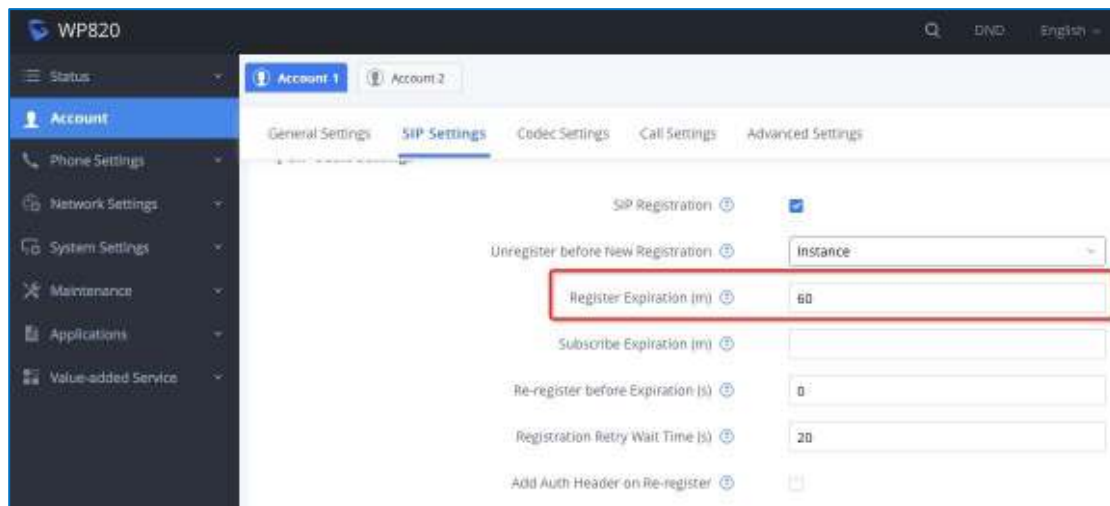
Figure 1: SIP Settings

Generally, the SIP registration interval is a relatively large value (3600 seconds), but in some special scenarios a smaller value (60 seconds or less) may be used, which will cause the system to wake up frequently to refresh the registration request. Please ensure that the “Register Expiration” a reasonable value.

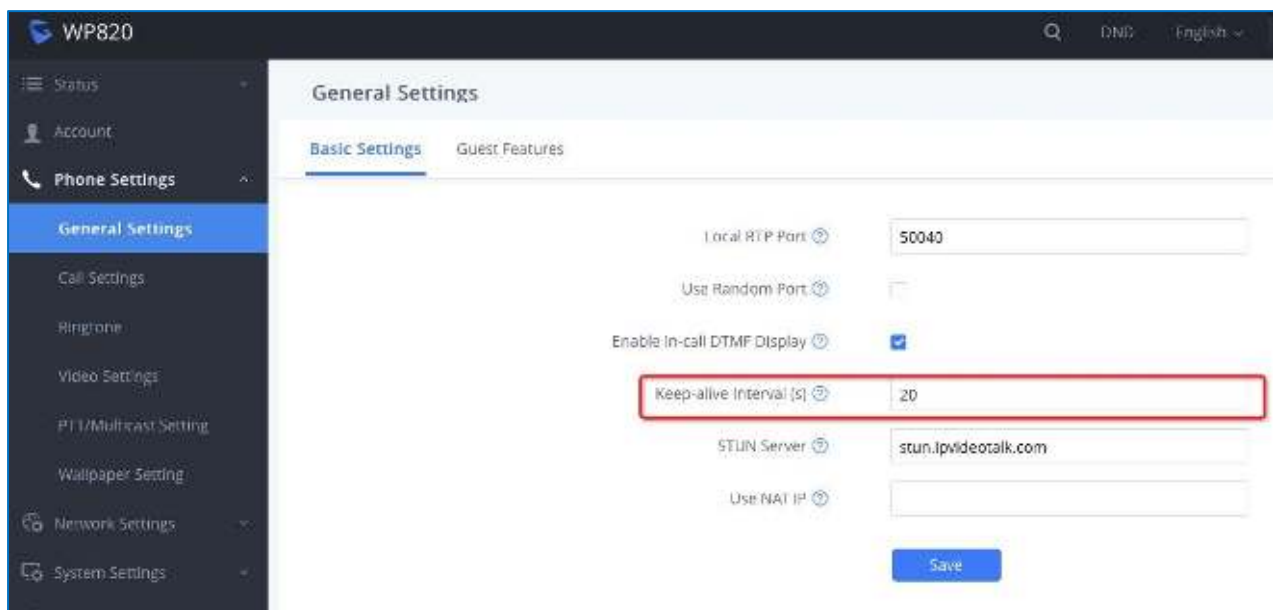
Figure 2: Basic Settings

If using a short interval for SIP or NAT keep alive it will affect the battery life significantly. Please first check if the device requires NAT keep-alive function to operate properly. If required to use NAT keep alive, please use an interval slightly lower than the refresh time of NAT mapping. For example, if the maintenance time of NAT mapping is 30 seconds, then the recommended keep-alive interval of NAT will be 25 seconds.

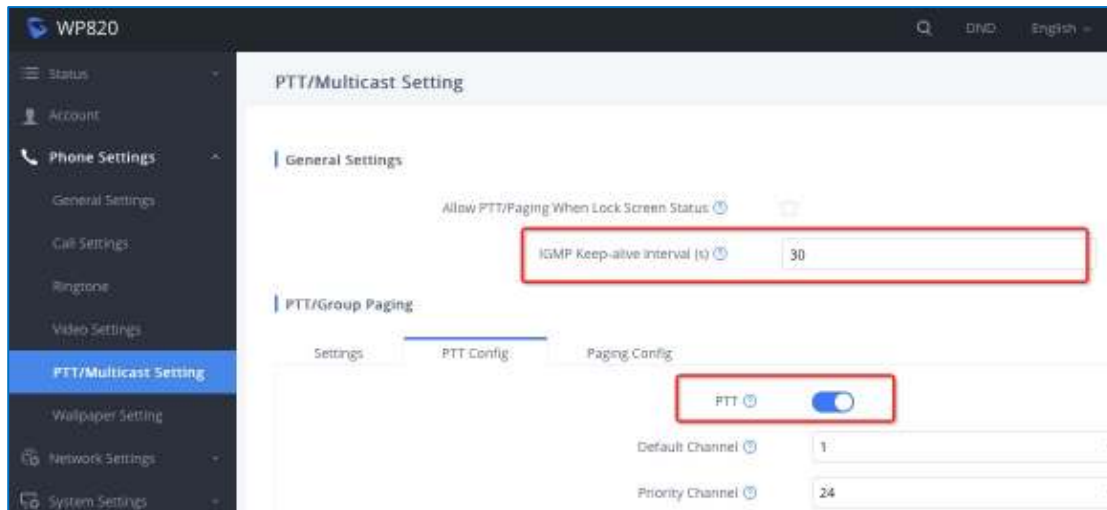
Figure 3: PTT/Multicast Setting

After the PTT function is enabled, the system will wake up periodically to process the multicast requests. Please adjust IGMP keep alive interval to an appropriate value. The default value is 30 seconds. Try to use a value of 40 seconds or greater but check that it does not affect PTT function. If the multicast feature is not needed, we suggest disabling it.

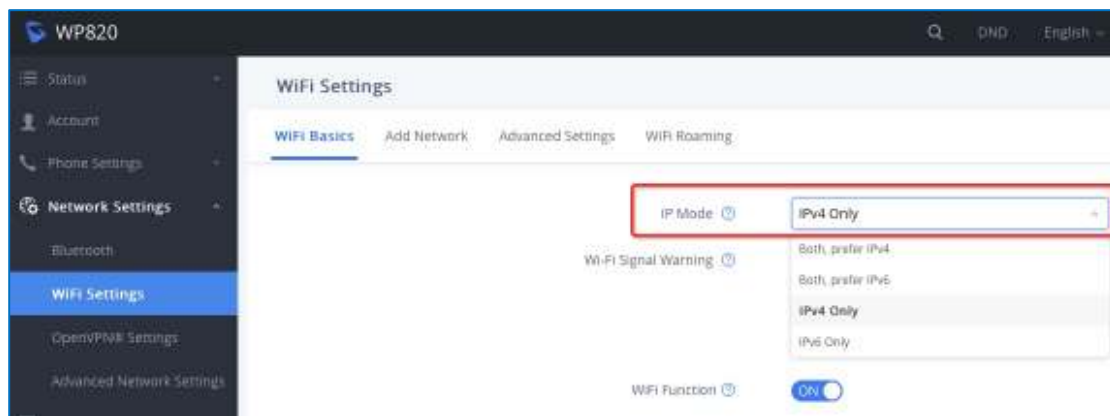
Figure 4: Wi-Fi Basics

IPv6, especially DHCPv6 multicast packets, will also cause the system to wake up frequently. If IPv6 is not used, it is recommended to set the network mode to "IPv4 Only".

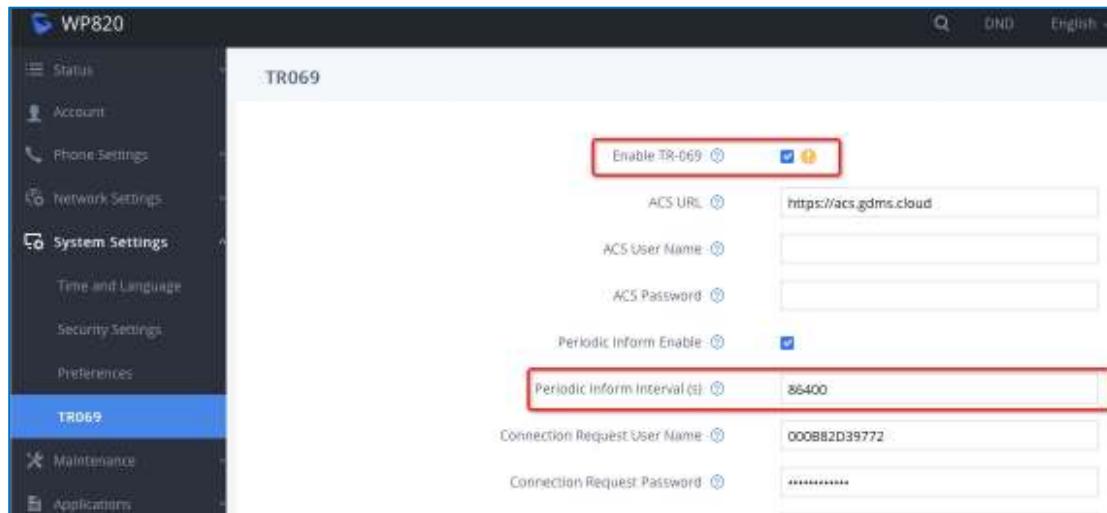
Figure 5: TR069

When the device opens TR-069 or Grandstream's GDMS function, it will cause the device to establish connection regularly and report relevant status to the server. Please turn off TR069 function or adjust the "Periodic Inform Interval" of TR069 to a longer duration.

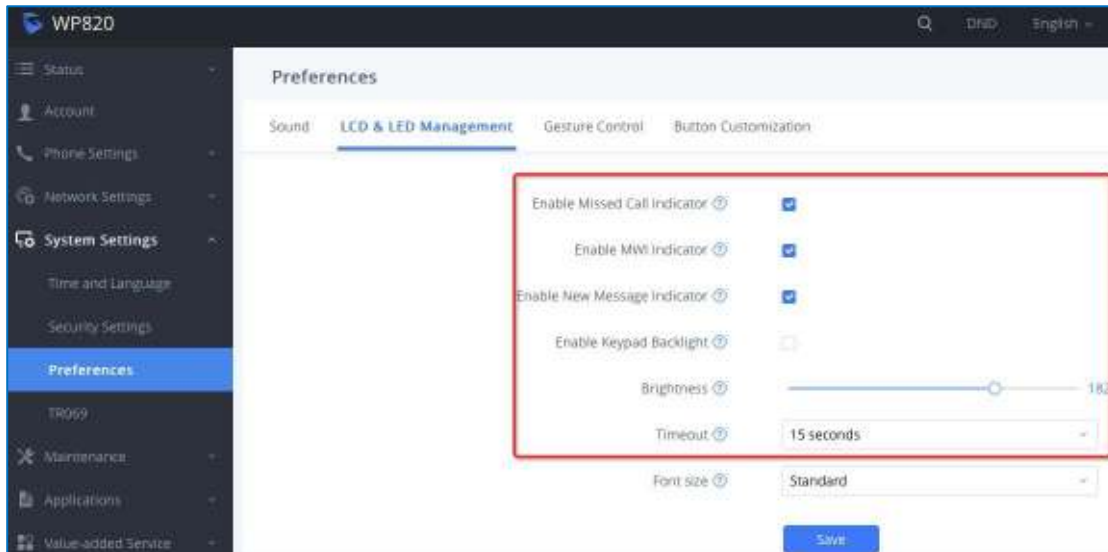
Figure 6: Preferences

1. Turn off the LED indicator light and the key backlight. Lower the brightness of the screen and set the screen timeout to 15s (minimum).
